Re: DRAFT US Ecology Waste Disposal Facility Explosion Trip Report,

Contract Number: EP-S7-13-07, Task Order Number: TO-520-002

US Ecology Waste Disposal Facility Explosion Grand View, Idaho TASK ORDER: TO-520-002

March 2019

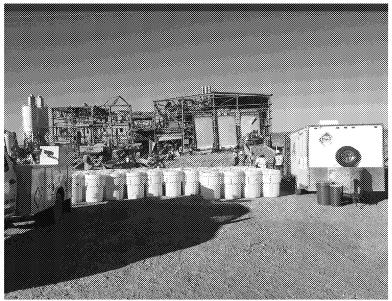
Photo 1 Observation Area in front of Stabilization and Containment buildings.

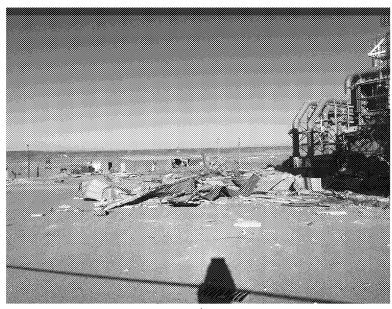
Photo 3 Damage to Pad 6 - RCRA/PCB Storage building.

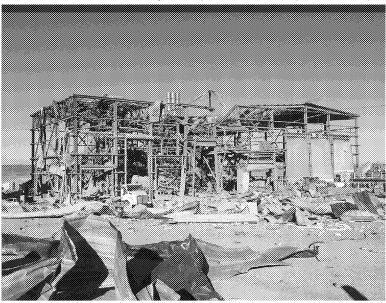
There were 21 employees at the site at the time of the explosion. Three workers from the facility were injured in the explosion and one fatality occurred. The Stabilization and Containment buildings were significantly damaged and the explosion caused some damage to surrounding buildings. There was an initial fire resulting from the explosion; however, the fire burned out by the evening of November 17.

Photo 2 Damage to Stabilization and Containment buildings.

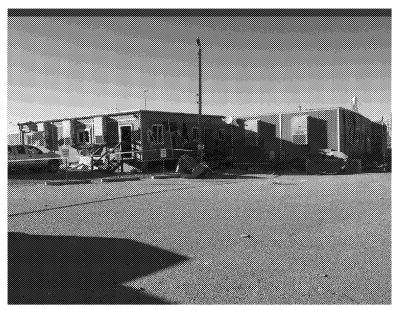
Photo 4 Damage to Administrations buildings from explosion.

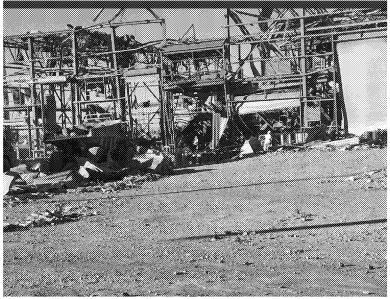
Photo 5 PRP Contractors in the Exclusion Zone preparing to move magnesium fines drums.

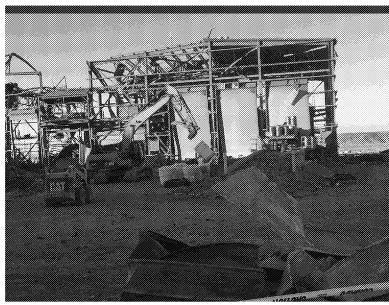
Photo 7 Preparing to overpack the drums from Drum Group 4.

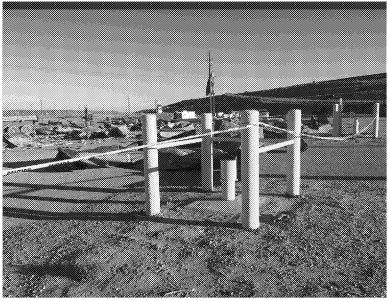
Photo 6 Monitoring location AS01.

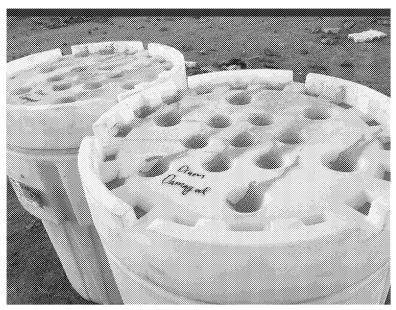
Photo 8 Close view of magnesium fines overpack labeling.

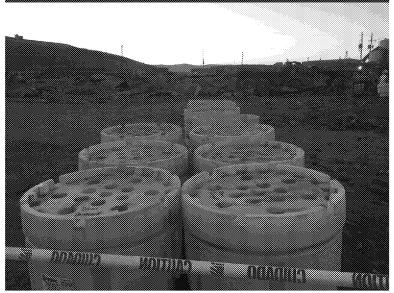
Photo 9 Staged magnesium fines drums from Drum Group 4.

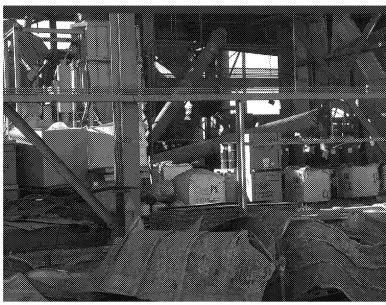
Photo 11 Flammable drums and solid waste totes in Containment Building.

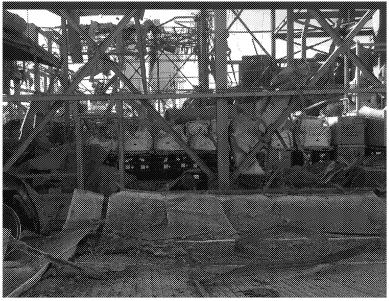
Photo 10 Containers and totes inside Containment Building.

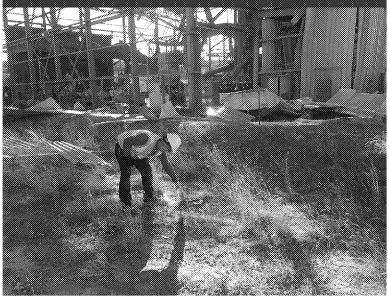
Photo 12 Drum lid on the northeast side of the Containment Building.

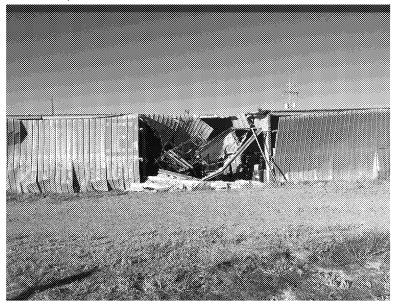
Photo 13 Close view of damage to Pad 6 building.

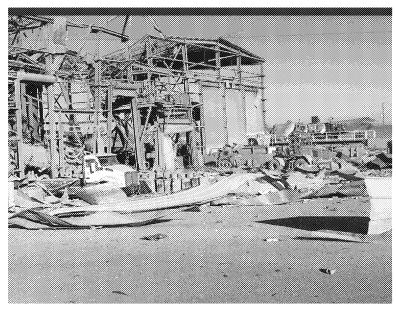
Photo 15 Drums in Drum Group 1 and 2.

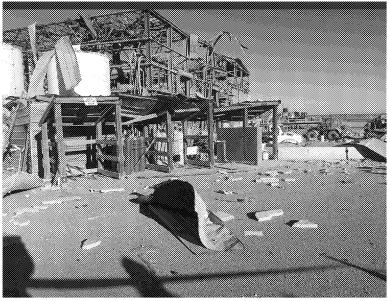
Photo 14 Cylinder Storage Area adjacent to Stabilization building.

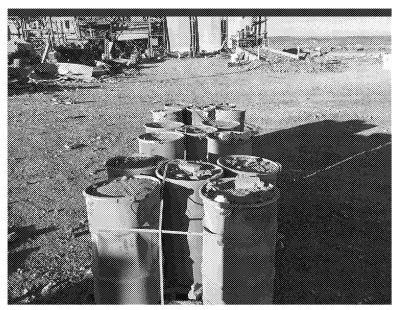
Photo 16 Magnesium waste and shavings drums from Drum Group 5.

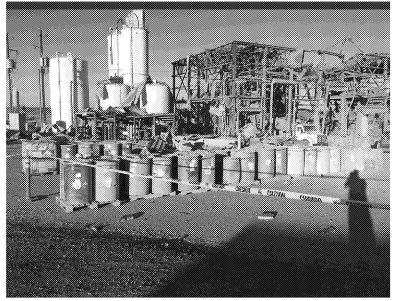
Photo 17 Segregated drums from Drum Group 1 and 2.

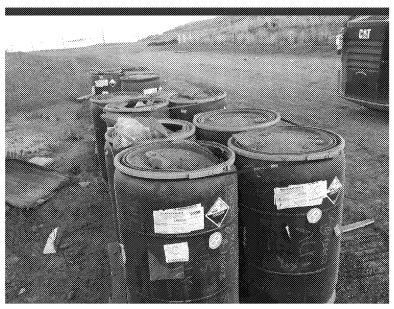
Photo 19 Damaged drums from Drum Group 6.

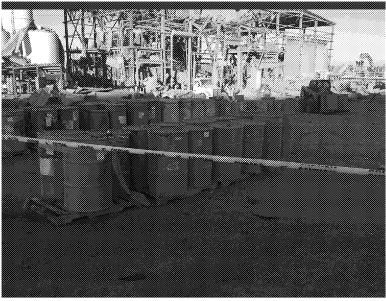
Photo 18 Drums from Drum Group 3 in foreground.

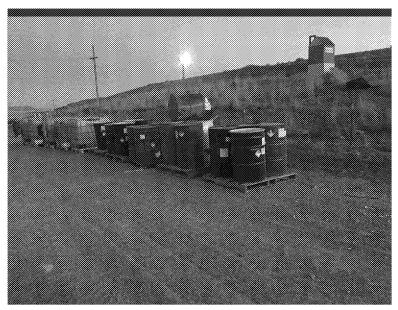
Photo 20 Drums and totes from Drum Group 7.

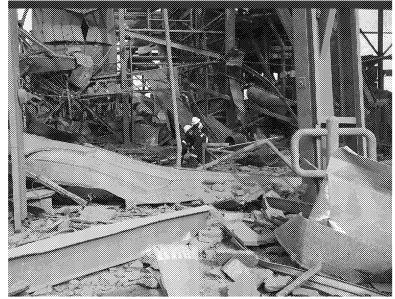
Photo 21 PRP representatives collecting samples inside the Containment building.

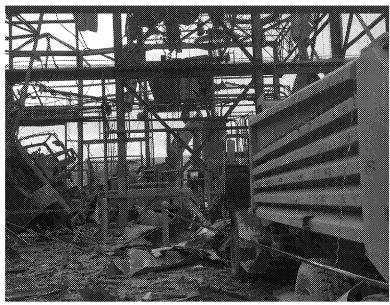
Photo 23 Damaged equipment and vehicles inside Stabilization building.

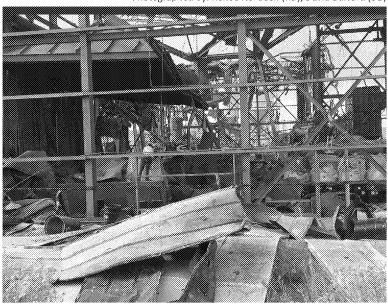
Photo 22 PRP representatives covering containers and totes inside the Containment building.

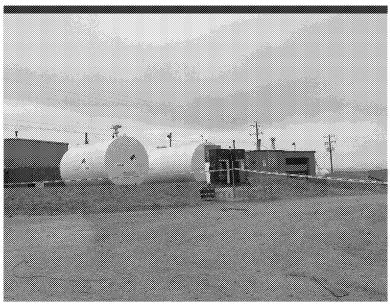
Photo 24 Undamaged tanks in tank farm adjacent to Stabilization Building.
